## **APPENDIX G**

### **DPR Forms**

State of California — The Resources Agency  
DEPARTMENT OF PARKS AND RECREATION  
**PRIMARY RECORD**

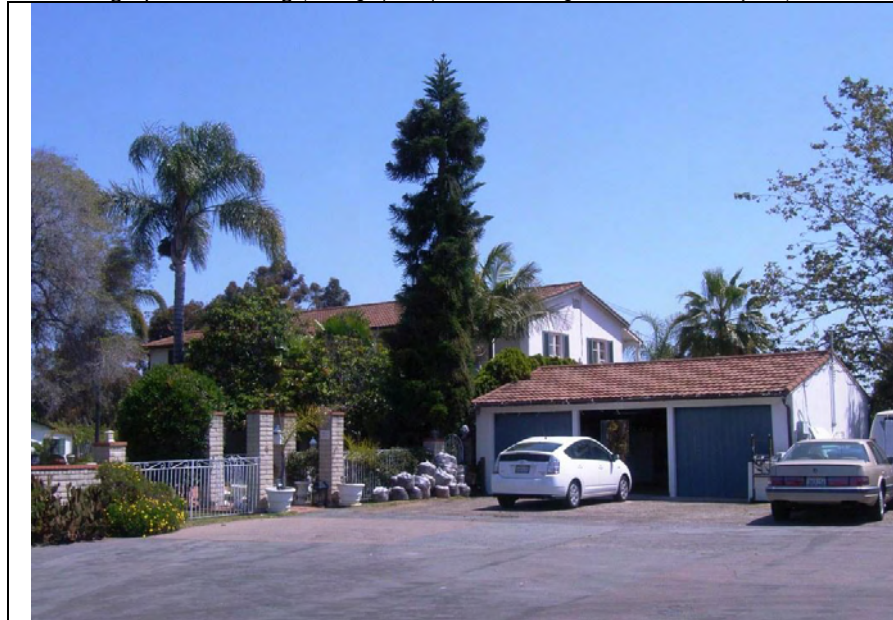
P5a. Photograph or Drawing (Photograph required for buildings, structures, and objects.)

21 Toyon Lane was constructed in 1931 in the Mediterranean Revival style. It is a two-story single family residential building located on the east side of Toyon Lane. The residence has a wood frame, rectangular floor plan with a concrete foundation. The exterior is clad in stucco siding. The roof is a moderately-pitched side gable roof clad in red clay tiles. On the west elevation, a concrete walkway leads to a partial-width recessed porch. There is an upper partial-width porch. The primary entrance could not be seen from the street at the time of the survey. The windows consist of wood casement windows. There is one chimney located within the roofline of the building. Landscape features include mature trees and a grass lawn.

View looking northeast at the building.

21 TOYON LN is recommended eligible as a Chula Vista Historic Resource under NRHP, CRHR and local criteria. In considering the building within the historic context prepared for this survey, it does not appear to be associated with any significant themes or patterns in history and therefore not eligible for Criteria A or 1. 21 TOYON LN is eligible as a Chula Vista Historic Resource under Criterion 2 for its association with Karl and Fern Helm, who made significant contributions locally as early members of the Chula Vista community as lemon growers, the owners of the first automobile service garage. 21 TOYON LN as an excellent local example of the Spanish Colonial Revival style, and as such is recommended eligible as a Chula Vista Historic Resource under Criterion 3. Character defining features of the Spanish Colonial Revival style include the stucco walls, red clay tile roof, upper story balcony. Following the same reasons, it is also eligible for the California Register of Historical Resources and National Register of Historic Places, on the local level, under Criterion 3 (CRHR) and Criterion C (NRHP). The building retains a significant degree of its building materials dating to the period of significance, especially in comparison to other similar properties. Overall it retains a high degree of integrity, especially of design, materials, and craftsmanship.

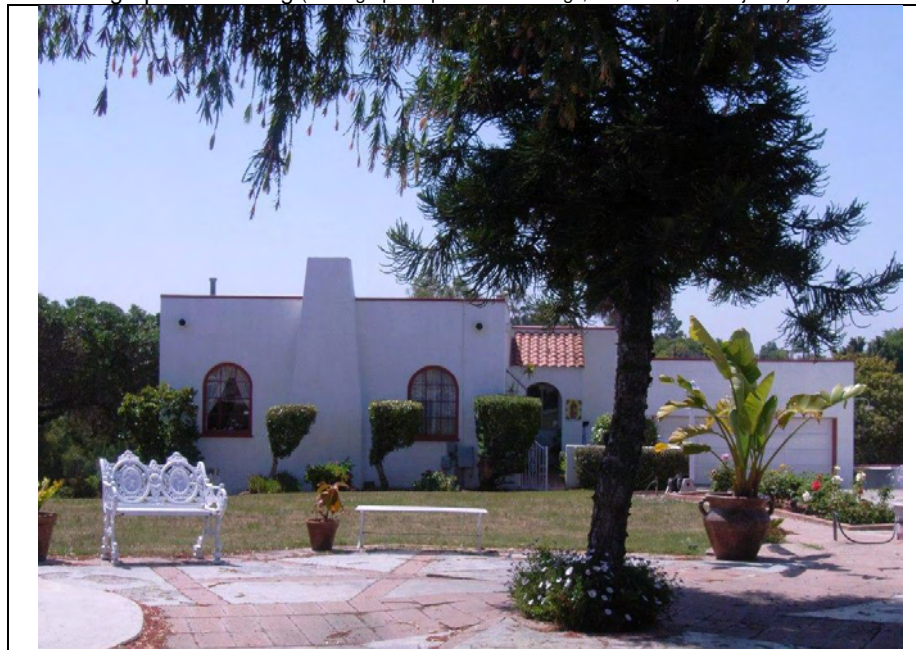
P5a. Photograph or Drawing (Photograph required for buildings, structures, and objects.)

24 Toyon Lane was constructed in 1928 in the Spanish Colonial Revival style. It is a one-story single family residential building located on the south side of Toyon Lane. The residence has a wood frame, near rectangular plan with a concrete foundation. The exterior is clad in stucco siding. The roof is flat. On the north elevation, a brick walkway and steps lead to a corner recessed porch. In front of the recessed porch is an open patio surrounded by a low stucco wall and an iron gate. The primary entrance is located within the porch and consists of a single wood door. The windows consist of fixed multi-light arched windows. There is one chimney located on the front façade exterior lateral. Modifications to the building include the replacement of some windows. Landscape features include a large patio and lawn as well as a side driveway. There is also an attached garage building.

View looking south at the building.

24 TOYON LN is recommended eligible as a Chula Vista Historic Resource under NRHP, CRHR and local criteria. In considering the building within the historic context prepared for this survey, it does not appear to be associated with any significant themes or patterns in history and therefore not eligible for Criteria A or 1. Additionally, no significant persons were identified in association with the property and it is not recommended eligible under Criteria B or 2. 24 TOYON LN as an excellent local example of the Spanish Colonial Revival style, and as such is recommended eligible as a Chula Vista Historic Resource under Criterion 3. Character defining features of the Spanish Colonial Revival style include the flat roof with raised parapet, arched windows, recessed porch, stucco wall, tapered stucco chimney and red tile coping. Following the same reasons, it is also eligible for the California Register of Historical Resources and National Register of Historic Places, on the local level, under Criterion 3 (CRHR) and Criterion C (NRHP). The building retains a significant degree of its building materials dating to the period of significance, especially in comparison to other similar properties. Overall it retains a high degree of integrity, especially of design, materials, and craftsmanship.

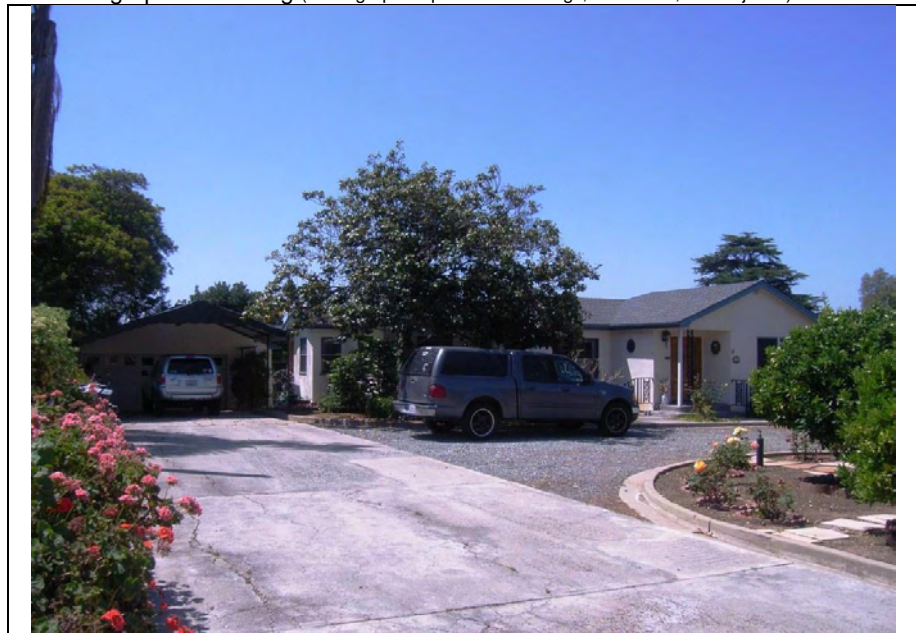
P5a. Photograph or Drawing (Photograph required for buildings, structures, and objects.)

30 Toyon Lane was constructed in 1942 in the Custom Ranch style. It is a one-story single family residential building located on the south side of Toyon Lane. The residence has a wood frame, L-shaped floor plan with a concrete foundation. The exterior is clad in stucco siding. The roof is a moderately-pitched front and side gable roof clad in asphalt shingles. On the north elevation, concrete walkway and steps lead to a recessed corner porch. The primary entrance is located within the porch and consists of a single wood door. The windows consist of double hung wood sash windows. Modifications to the building include the replacement of doors, windows and porch supports. Landscape features include a gravel driveway.

View looking southwest at the building.

30 TOYON LN is recommended eligible as a Chula Vista Historic Resource under NRHP, CRHR and local criteria. In considering the building within the historic context prepared for this survey, it does not appear to be associated with any significant themes or patterns in history and therefore not eligible for Criteria A or 1. Additionally, Dwight Gove was found associated with the property, however, research did not indicate that he was an important individual locally. Therefore the building is not recommended eligible under Criteria B or 2. 30 TOYON LN as an excellent local example of the Custom Ranch style, and as such is recommended eligible as a Chula Vista Historic Resource under Criterion 3. Character defining features of the Custom Ranch style include the rambling floor plan, widely-pitched roof, varying siding materials. Following the same reasons, it is also eligible for the California Register of Historical Resources and National Register of Historic Places, on the local level, under Criterion 3 (CRHR) and Criterion C (NRHP). The building retains a significant degree of its building materials dating to the period of significance, especially in comparison to other similar properties. Overall it retains a high degree of integrity, especially of design, materials, and craftsmanship.

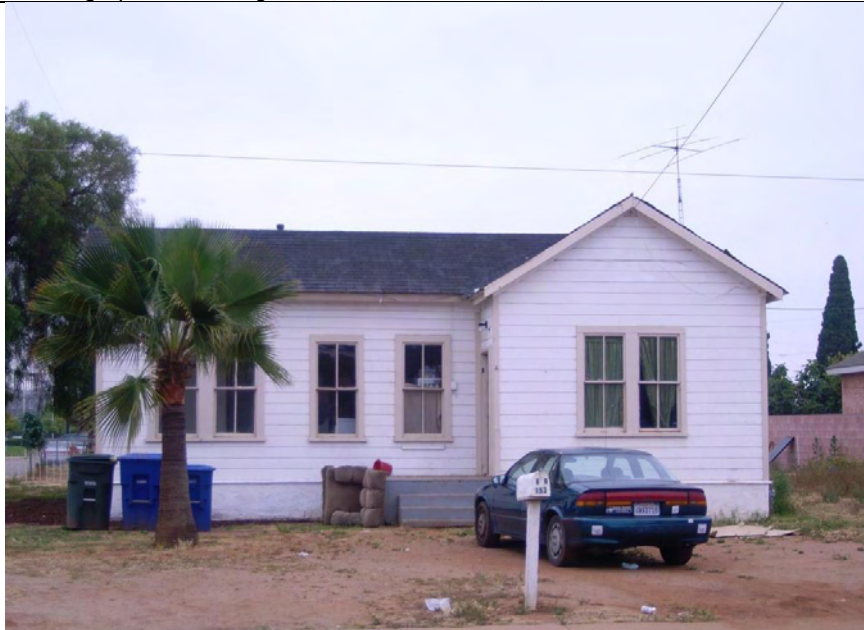
P5a. Photograph or Drawing (Photograph required for buildings, structures, and objects.)

153 Tremont Street was constructed circa 1900 in the Vernacular- Early Settlement style. It is a one-story single family residential building located on the southeast side of Albany Avenue and Tremont Street. The residence has a wood frame, L-shaped floor plan with a concrete foundation. The exterior is clad in horizontal wood board siding. The roof is a moderately-pitched front and side gable roof with shallow eaves and clad in an asphalt roll. On the north elevation, concrete steps lead to an open stoop. The primary entrance is located within the stoop and consists of a single wood door. The windows consist of double hung wood sash windows. Modifications to the building include the replacement of windows. Landscape features include a dirt yard.

View looking south at the building.

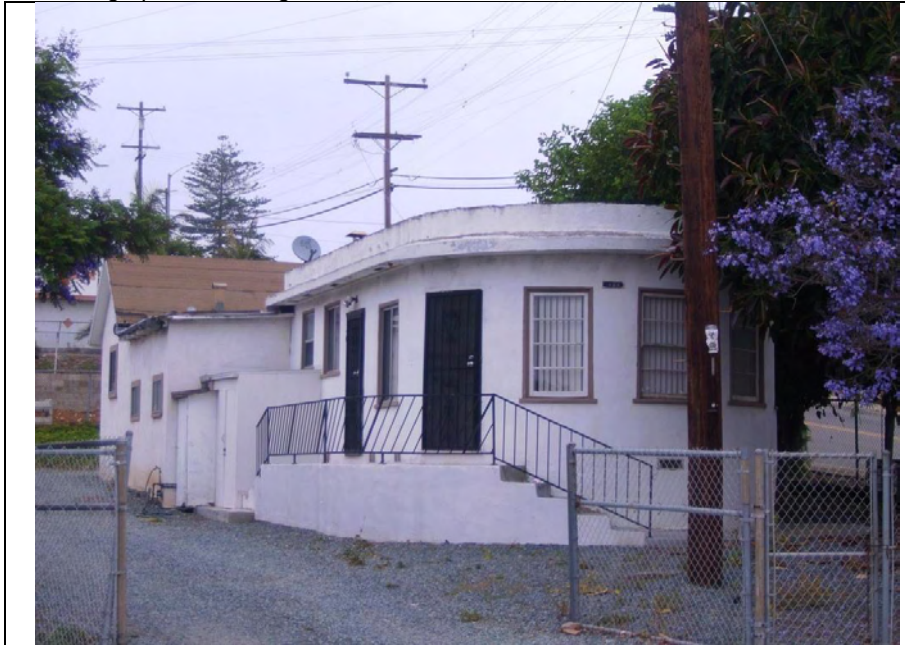
P5a. Photograph or Drawing (Photograph required for buildings, structures, and objects.)

154 Tremont Street was constructed in 1940 in the Streamline Moderne style. It is a one-story single family building located on the north side of Tremont Street and Albany Avenue. The residence has a wood frame, irregular floor plan with a concrete foundation. The exterior is clad in stucco siding. The roof is a flat with a raised parapet. A flat hood surrounds the building. On the south elevation, concrete steps lead to a partial-width open porch. The primary entrance is located within the porch and consists of two single doors obscured by metal security doors. The windows consist of aluminum sliders and wood sash windows. Additions include a front and side gable one-story building on the north section of the building. Modifications to the building include the replacement of windows. Landscape features include a dirt and gravel yard.

View looking north at the building.

154 TREMONT ST is recommended eligible as a Chula Vista Historic Resource under NRHP, CRHR and local criteria. In considering the building within the historic context prepared for this survey, it does not appear to be associated with any significant themes or patterns in history and therefore not eligible for Criteria A or 1. Additionally, no significant persons were identified in association with the property and it is not recommended eligible under Criteria B or 2. 154 TREMONT ST as an excellent local example of the Streamline Moderne style, and as such is recommended eligible as a Chula Vista Historic Resource under Criterion 3. Character defining features of the Streamline Moderne style include the curved wall surface, horizontal bands. Following the same reasons, it is also eligible for the California Register of Historical Resources and National Register of Historic Places, on the local level, under Criterion 3 (CRHR) and Criterion C (NRHP). The building retains a significant degree of its building materials dating to the period of significance, especially in comparison to other similar properties. Overall it retains a high degree of integrity, especially of design, materials, and craftsmanship.

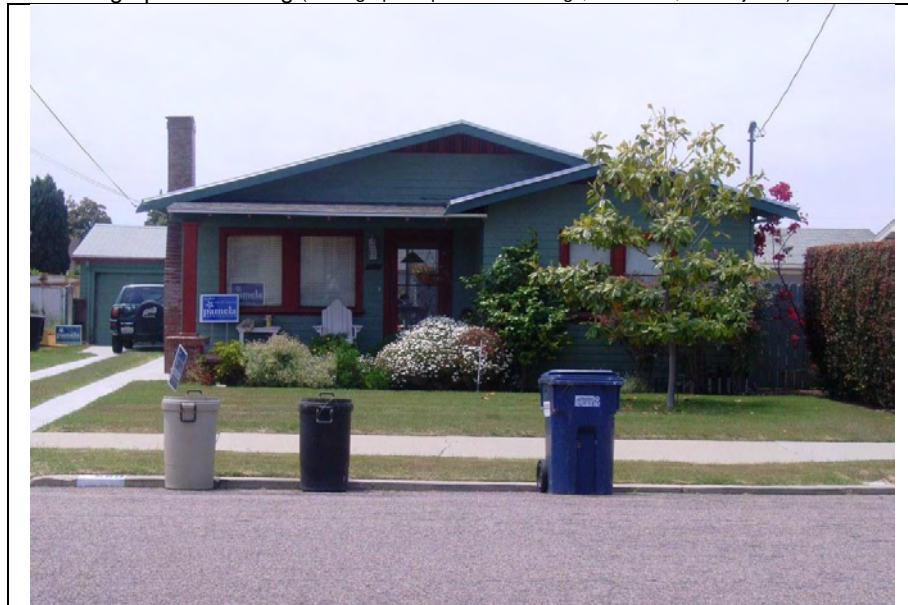
P5a. Photograph or Drawing (Photograph required for buildings, structures, and objects.)

580 Twin Oaks Avenue was constructed in 1929 in the Craftsman style. It is a one-story single family residential building located on the west side of Twin Oaks Avenue, north of I Street. The residence has a wood frame, rectangular floor plan with a concrete foundation. The exterior is clad in horizontal wood board siding. The roof is a widely-pitched front gable roof and clad in composition shingle. On the east elevation, brick steps lead to a partial-width porch with a shed roof. A single squared wooden column sitting atop a brick pier supports the porch roof. The primary entrance is located within the porch and consists of a single wood door. The windows consist of one-over-one double hung sash windows. There is one chimney on the south exterior lateral. There is also a detached garage located to the rear of the residence. There appear to be no modifications to the building. Landscape features include a front lawn, a concrete driveway and small trees and bushes.

View looking west at the building.

580 TWIN OAKS AV is recommended eligible as a Chula Vista Historic Resource under NRHP, CRHR and local criteria. In considering the building within the historic context prepared for this survey, it does not appear to be associated with any significant themes or patterns in history and therefore not eligible for Criteria A or 1. 580 TWIN OAKS AV as an excellent local example of the Craftsman style, and as such is recommended eligible as a Chula Vista Historic Resource under Criterion 3. Character defining features of the Craftsman style include the widely-pitched roof, partial-width porch, wood sash windows, wood clapboard siding, and overhanging eaves. Following the same reasons, it is also eligible for the California Register of Historical Resources and National Register of Historic Places, on the local level, under Criterion 3 (CRHR) and Criterion C (NRHP). 580 TWIN OAKS AV is also eligible as a Chula Vista Historic Resource under Criterion 3 for its association with Arthur Done, who was a significant builder and former mayor of Chula Vista. Done constructed the Chula Vista Women's Clubhouse (1928) as well as the builder of houses of other significant individuals in Chula Vista such as Greg Cox and Arthur Day. The building retains a significant degree of its building materials dating to the period of significance, especially in comparison to other similar properties. Overall it retains a high degree of integrity, especially of design, materials, and craftsmanship.

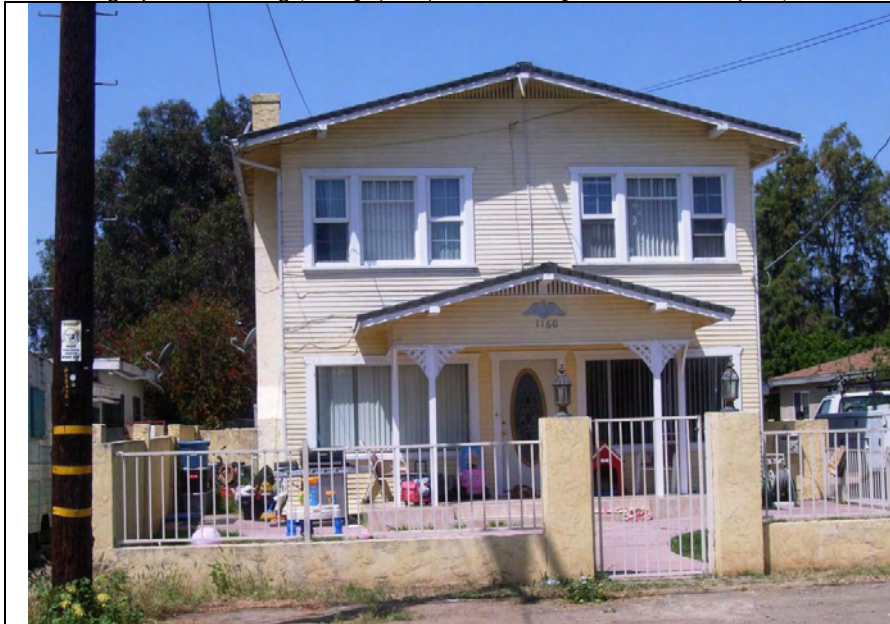
P5a. Photograph or Drawing (Photograph required for buildings, structures, and objects.)

1160 Twin Oaks Avenue was constructed in 1924 in the Craftsman style. It is a two-story single family residential building located on the west side of Twin Oaks Avenue. The residence has a wood frame, rectangular floor plan with a concrete foundation. The exterior is clad in horizontal wood siding. The roof is a widely-pitched front gable roof with overhanging eaves and exposed purlins and clad in composition shingles. On the east elevation, a concrete walkway leads to a partial-width porch with a front gable roof. The porch roof is supported by squared wooden posts. The primary entrance is located within the porch and consists of a single wood door with glazing. The windows consist of vinyl sash windows. There are vents underneath the gable ends. There is also a chimney on the south elevation exterior lateral. Additions include a one-story addition at the rear of the building. Modifications to the building include the replacement of doors, windows and porch supports. Landscape features include a concrete wall with iron railings surrounding the property.

View looking west at the building.

1160 TWIN OAKS AV is not recommended eligible as a Chula Vista Historic Resource under any NRHP or CRHR or local criteria. In considering the building within the historic context prepared for this survey, it does not appear to be associated with any significant themes or patterns in history and therefore not eligible for Criteria A or 1. Additionally, no significant persons were identified in association with the property and it is not recommended eligible under Criteria B or 2. Although 1160 TWIN OAKS AV possesses some stylistic features of the Craftsman style, it is not a good representative of the style and is not recommended eligible under Criteria C or 3.

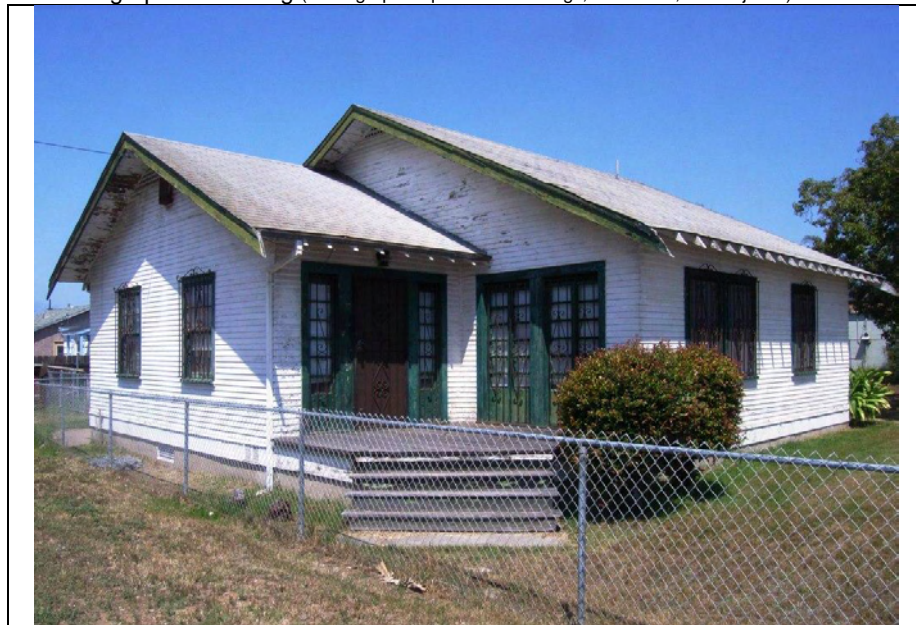
P5a. Photograph or Drawing (Photograph required for buildings, structures, and objects.)

1198 Twin Oaks Avenue was constructed in 1935 in the Craftsman style. It is a one- and one-half story building located on the northeast side of Twin Oaks Avenue and Oxford Street. The residence has a wood frame, rectangular floor plan with a concrete foundation. The exterior is clad in horizontal wood board siding. The roof is a moderately-pitched front gable roof with overhanging eaves and exposed rafter tails and clad in a composition roll. On the south elevation, wood steps lead to an open porch on the southeast corner of the building. The primary entrance is located on the southeast corner of the building and consists of a single wood door with side lights. The windows consist of double hung wood sash windows. Metal security bars obscure the windows. Other buildings on the parcel lot include a garage and a shed. Landscape features include a surrounding yard and a chain-link fence surrounding the property.

View looking northwest at the building.

1198 TWIN OAKS AV is recommended eligible as a Chula Vista Historic Resource under NRHP, CRHR and local criteria. In considering the building within the historic context prepared for this survey, it does not appear to be associated with any significant themes or patterns in history and therefore not eligible for Criteria A or 1. Additionally, no significant persons were identified in association with the property and it is not recommended eligible under Criteria B or 2. 1198 TWIN OAKS AV as an excellent local example of the Craftsman style, and as such is recommended eligible as a Chula Vista Historic Resource under Criterion 3. Character defining features of the Craftsman style include the widely-overhanging eaves, exposed rafter tails and purlins, wood clapboard siding. Following the same reasons, it is also eligible for the California Register of Historical Resources and National Register of Historic Places, on the local level, under Criterion 3 (CRHR) and Criterion C (NRHP). The building retains a significant degree of its building materials dating to the period of significance, especially in comparison to other similar properties. Overall it retains a high degree of integrity, especially of design, materials, and craftsmanship.

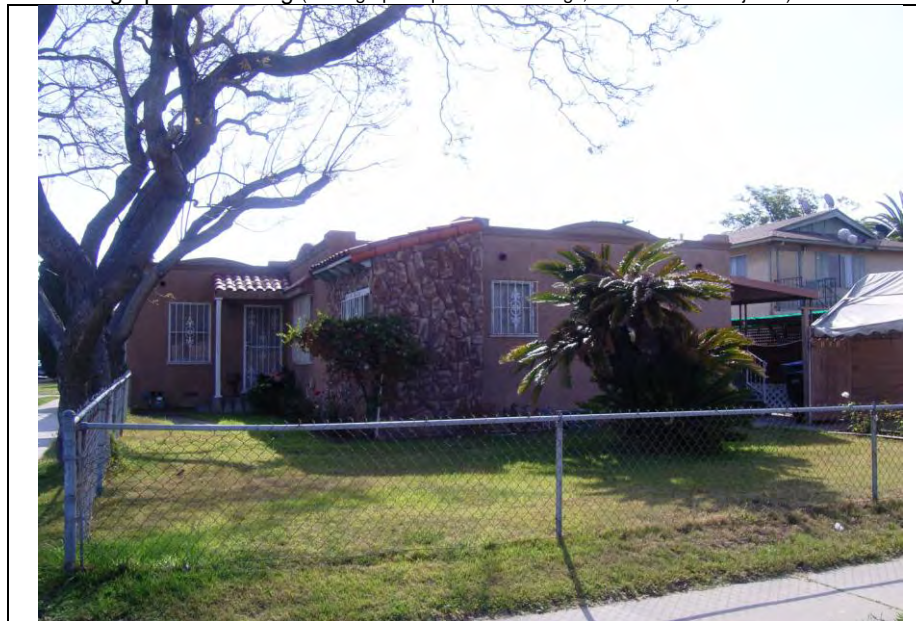
P5a. Photograph or Drawing (Photograph required for buildings, structures, and objects.)

101 Woodlawn Avenue was constructed in 1927 in the Spanish Colonial Revival style. It is a one-story single family residential building located on the east side of Woodlawn Avenue, north of D Street. The residence has a wood frame, rectangular floor plan with a concrete foundation. The exterior is clad in stucco and stone veneer. The roof is flat with a raised parapet. On the east elevation, a concrete walkway and steps lead to a partial-width porch with a shed roof covered in red clay tiles. The primary entrance is located within the porch and consists of a single door obscured by a metal security door. The windows consist of double hung aluminum sash windows. There are metal security bars over the windows. Additions include a shed roof addition and a detached garage building. Modifications to the building include the stone veneer siding and the metal security bars. Landscape features include a grass lawn and a chain-link fence.

View looking southeast at the building.

101 WOODLAWN AV is not recommended eligible as a Chula Vista Historic Resource under any NRHP or CRHR or local criteria. In considering the building within the historic context prepared for this survey, it does not appear to be associated with any significant themes or patterns in history and therefore not eligible for Criteria A or 1. Additionally, no significant persons were identified in association with the property and it is not recommended eligible under Criteria B or 2. Although 101 WOODLAWN AV possesses some stylistic features of Spanish Colonial Revival style, it is not a good representative of the style and is not recommended eligible under Criteria C or 3.

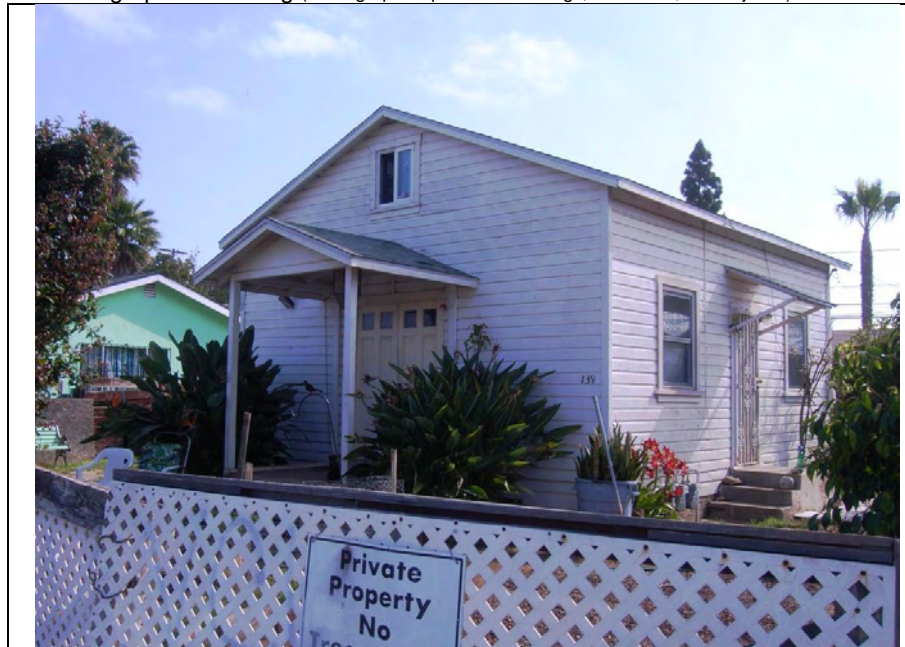
P5a. Photograph or Drawing (Photograph required for buildings, structures, and objects.)

View looking east at the building.

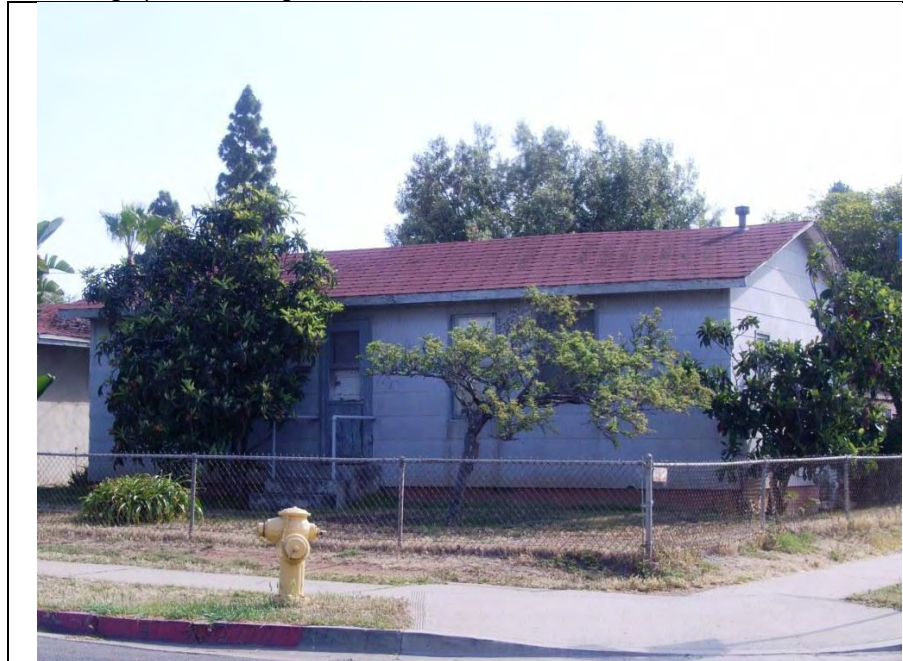
P5a. Photograph or Drawing (Photograph required for buildings, structures, and objects.)

View looking east at the building.

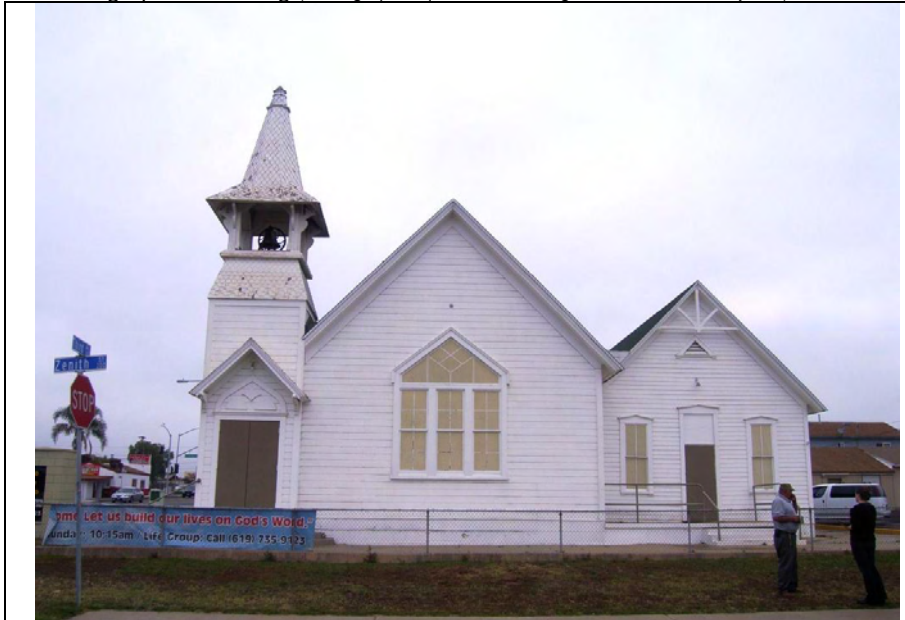
P5a. Photograph or Drawing (Photograph required for buildings, structures, and objects.)

View looking north at the church.

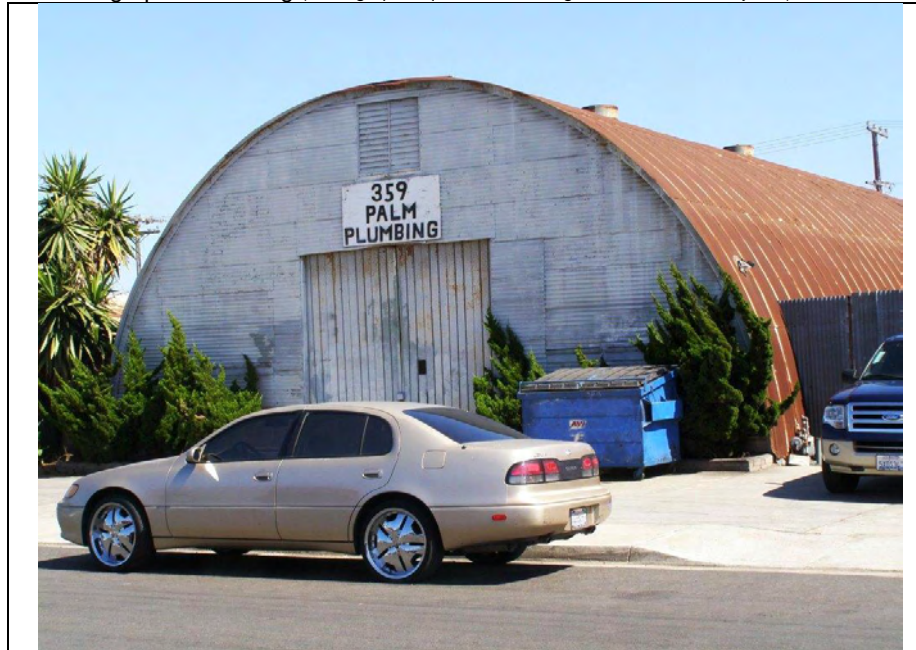
P5a. Photograph or Drawing (Photograph required for buildings, structures, and objects.)

View looking southeast at the building.

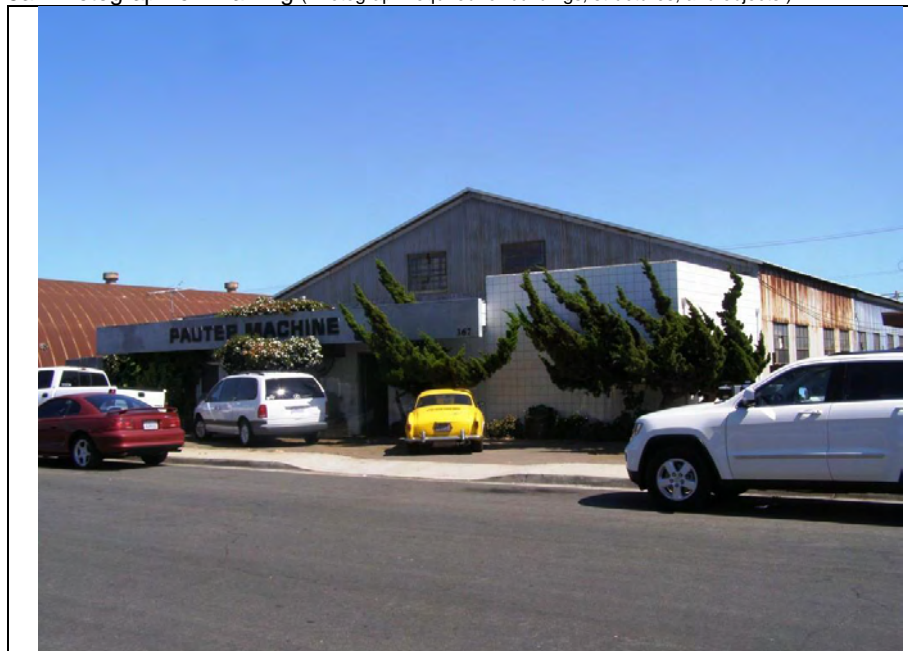
P5a. Photograph or Drawing (Photograph required for buildings, structures, and objects.)

View looking southeast at the building.
